Traffic Engineering Guidance Cannon Air Force Base, New Mexico 1 February 2001

Whitefield W. Mayes, P.E.
Chief of Special Projects Office
Military Traffic Management Command
Transportation Engineering Agency
Newport News, VA

Study Objectives

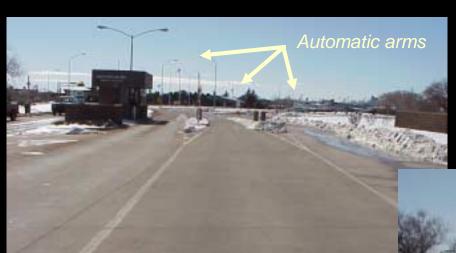
Recommendations for at Main Gate

Confusing 3-lane approach to Main Gate (which lane is open?)

- Main Gate area, to include intersection of D L Ingram and Torch Blvds.
 - Install wider red and white striped gate arms with black-on-white, 36"x24"
 LANE CLOSED signs (similar to R11-2 in MUTCD).
 - Use orange, reflectorized traffic cones to guide inbound motorists into the correct ID check lane(s).
 - Re-mark and sign the southwest leg of the D L Ingram Torch intersection to allow for a free-flowing merge for southwestbound traffic. This requires that the inbound separate right-turn lane be restricted to one lane. Install diamond, black-on-yellow Added Lane signs (W4-3) and paint according to the design sketch provided during out-brief.
 - Cut away a small portion of the median nose on the NW leg to provide a more natural path for vehicles turning left to exit the base.

Enlarge arms and signs

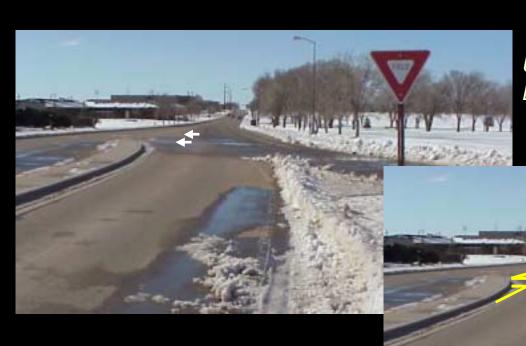
Unclear merge of southwestbound D L Ingram at Torch inbound ramp

Stripping to permit each flow to proceed into separate lane

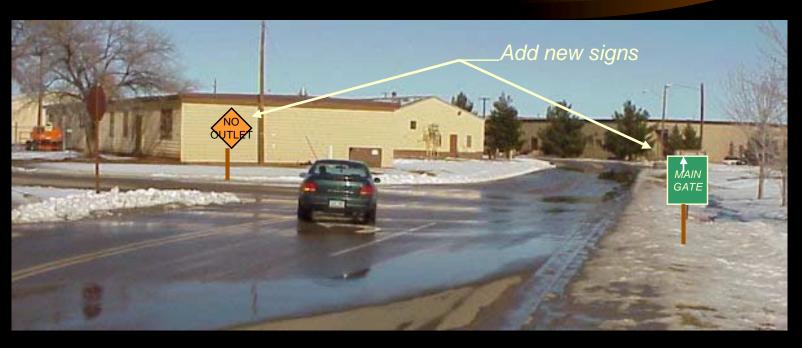
Intersection of Torch Blvd and Engineers' Way

Signs needed to clarify that Engineers'Way is a dead end street

Add two signs (NO OUTLET and MAIN GATE) to clarify that Engineers'
 Way (old Torch Blvd) is no longer the route to Main Gate.
